# **USS KLAKRING (FFG 42)**

# SHELL CONDITION ASSESSMENT SURVEY INTERIOR AREAS

3/26/01 - 4/6/01

**SUPSHIP PORTSMOUTH**

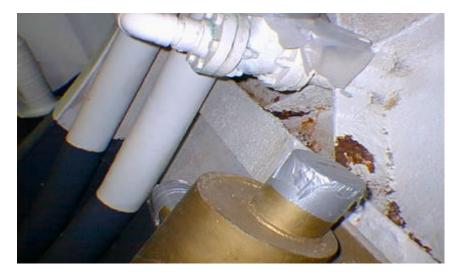
Heavy corrosion around CHT overboard, stbd shell, FR 166. Shell is thinned but is still over 75% of original thickness.

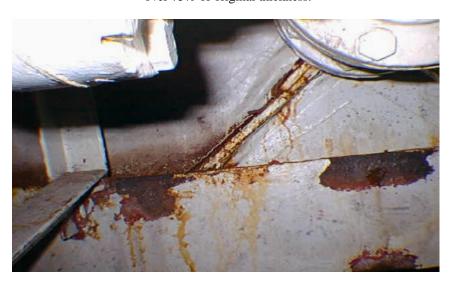
Additional view of overboard area.

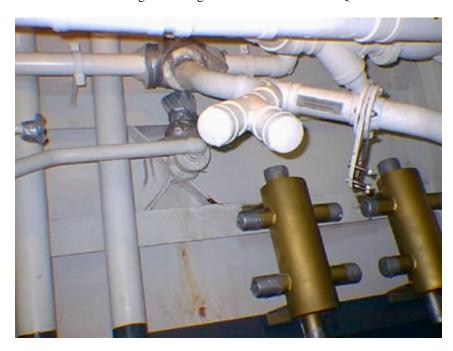
View of the stbd shell Fr 164-172. Fresh anti-sweat coating masks heavy scaling of shell and stiffeners.

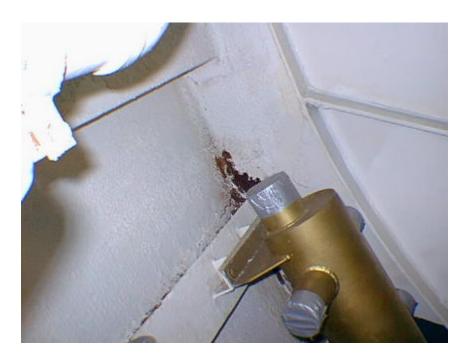
Corrosion at Fr 172, stbd, bhd to F/F PUMP ROOM. Bhd is thin, but not holed after needle gunning  $\,$

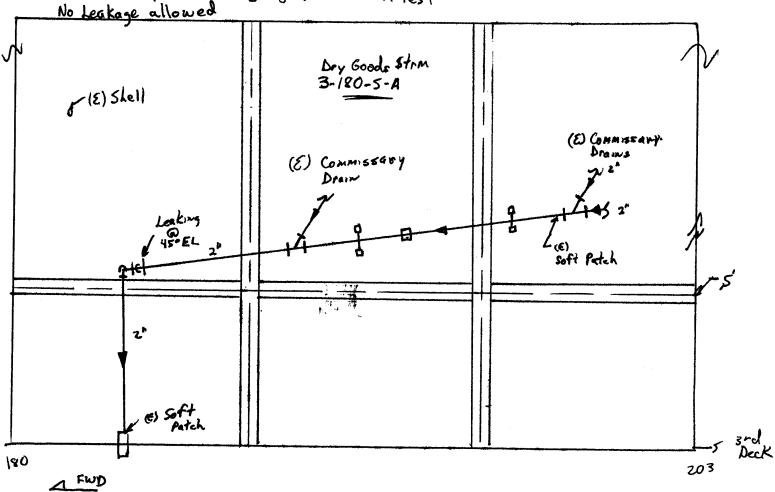
Partial Elevation
Frang outbol to 5+60
NTS

1 Remove and Repair (E) Soft petch areas 5 Clear Preserve and Stered piping
2 Remove 45° Eld and visually inspect piping
3 Install New 45° Eld and
4 Test New/repaired Diping by operational test
No Leakage allowed

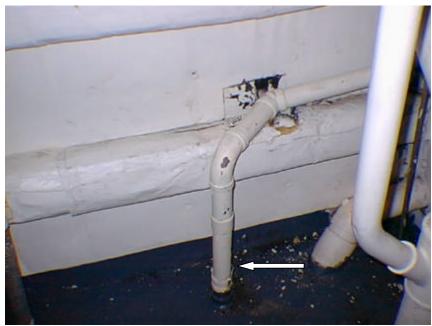
Leaking drain line, Fr 186, stbd. At the deck, a soft patch is visible

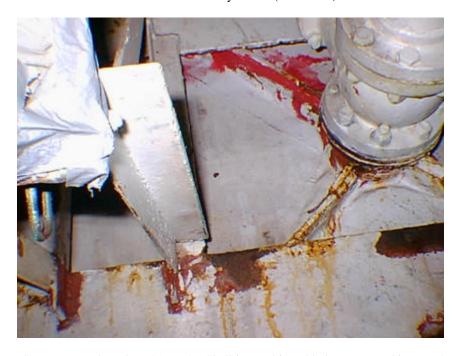
Seawater overboard, Fr 216, U/L. Shell is not thinned below specs. This area should not be lagged.

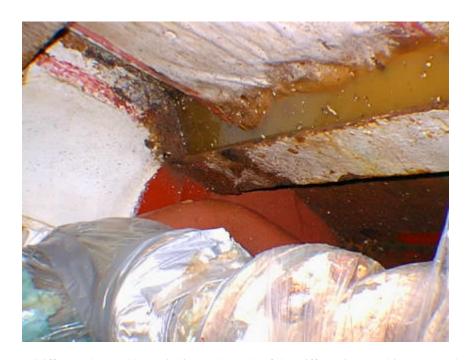
Stiffener P8, Fr 218. UT indicates the web of the stiffener is very thin. A weep hole in this area would reduce the corrosion.

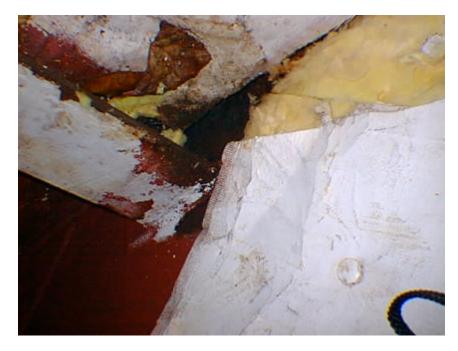
Corrosion at the intersection of BHD 212, port shell and P9. Areas look bad, but UT's indicate they are within specs. Another place that should not be lagged.

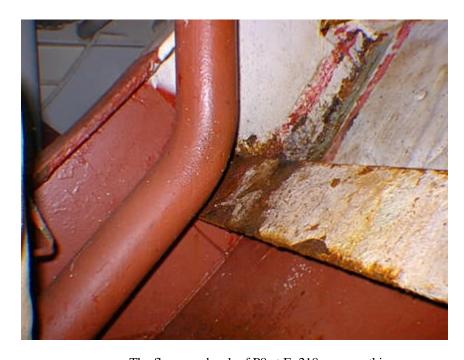
The flange and web of P8 at Fr 218 are very thin.

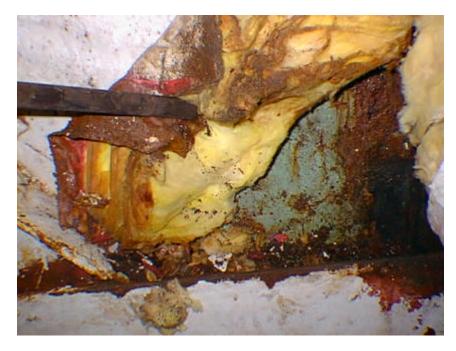
Heavy corrosion behind lagging at the connection between P9, the shell and BHD 212. UT readings indicate thinned areas but all within specs  $\frac{1}{2}$

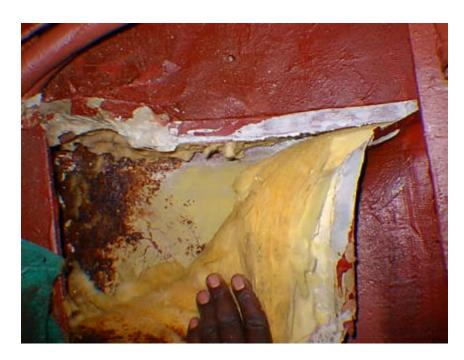
Similar corrosion on P9 at Fr 226. UT's indicate this is mainly surface corrosion at this time.

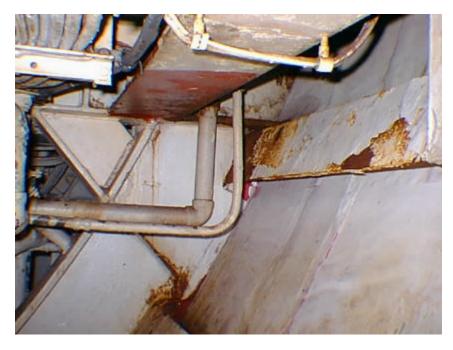
Corrosion, portside, outboard of the HPAC, Fr 218, just below the U/L grating.

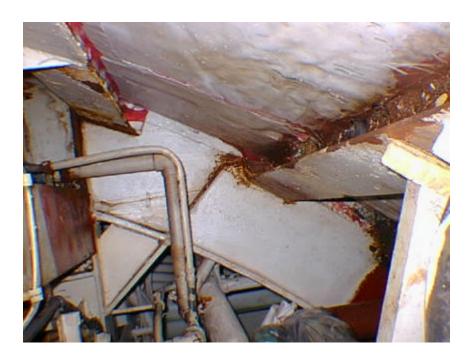
Additional view of same area, showing corrosion in the web of P9.

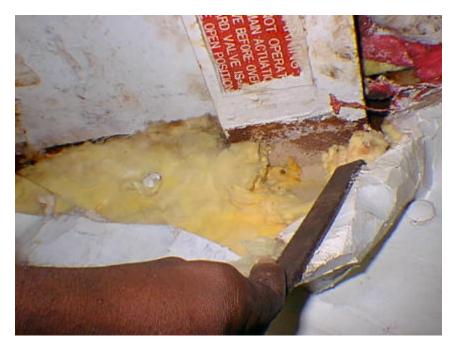
Corrosion at the connection between the shell and the Transverse bhd at Fr 212. Bhd is thinned but within specs.

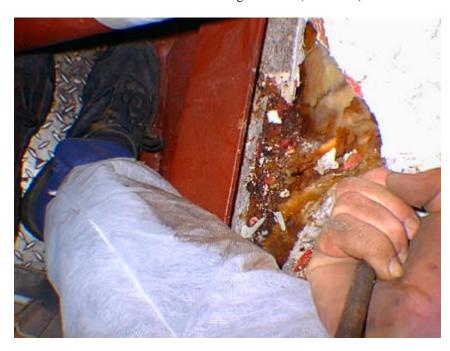
This level of corrosion was common on all L/L areas where lagging was opened for inspection.

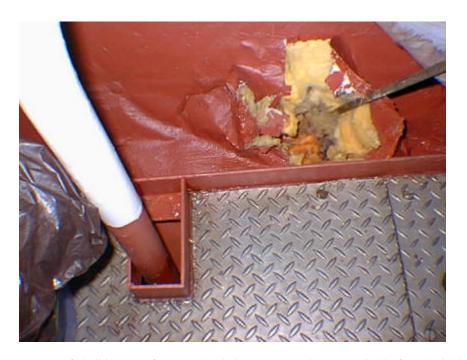
Areas of shell in way of weep holes below overboards was typically found with heavy corrosion

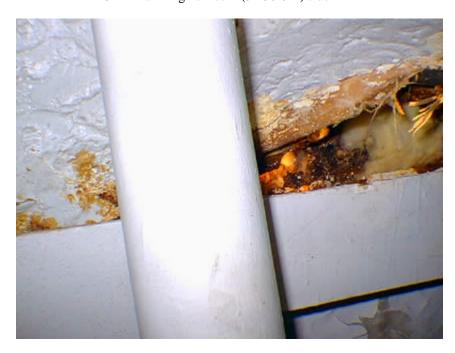
Lagging saturated above the bilge level, Fr 260, stbd side.

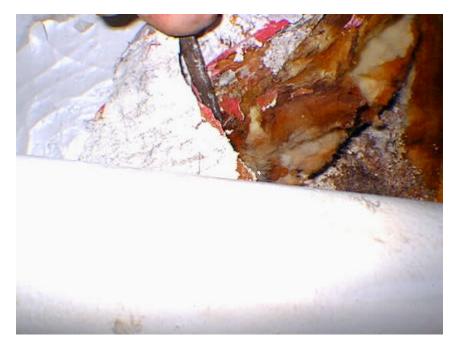
Extreme corrosion behind lagging in way of lube oil cooler ovbd, Fr 272 stbd side.

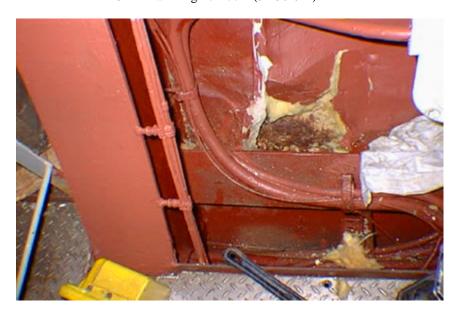
Corrosion behind lagging that otherwise appears satisfactory.

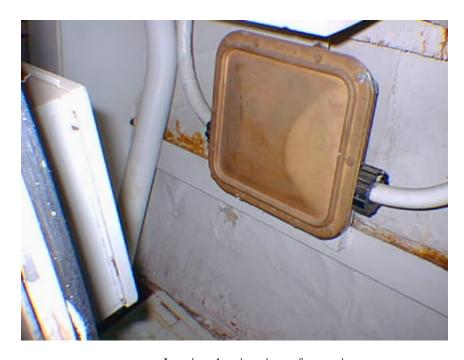
Lagging showing signs of saturation

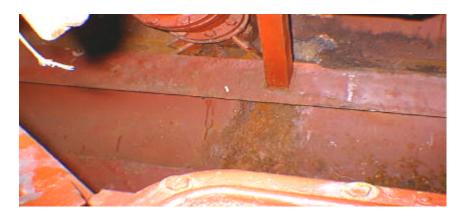
Corrosion under Prairie Masker cooler, around overboard. Some thin plate was determined by UT. See UT grid.

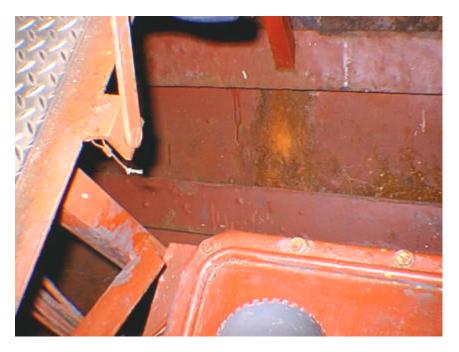
Additional view of same area

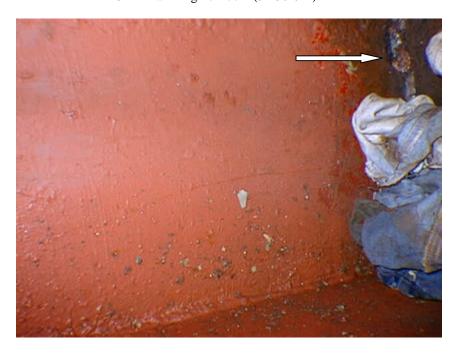
Arrow indicates what appears to be a doubler plate on the keel side of the margin plate. Anomaly is at Fr 271, port side. Note the heavy corrosion of the area. Shipsforce indicated the bilges were to be cleaned and preserved by the shipyard.

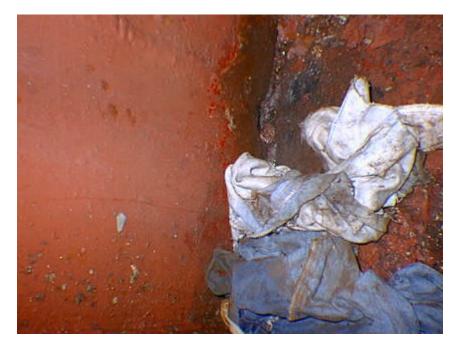
Closer view of doubler plate. No action needs to be taken.

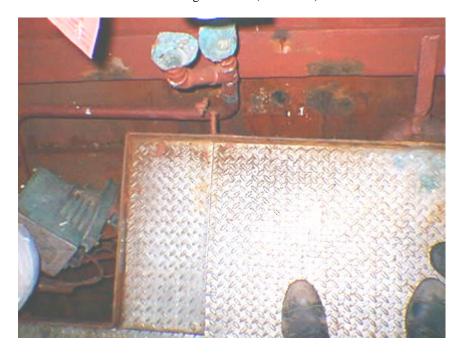
Area under Prairie Masker cooler, Fr 268, port side L/L. Seawater leakge and drains have caused localized shell thinning. See UT grids.

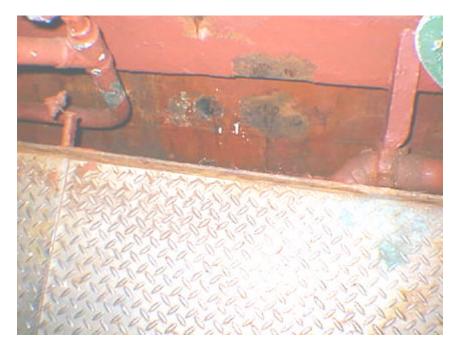
Closer view of areas defined above.

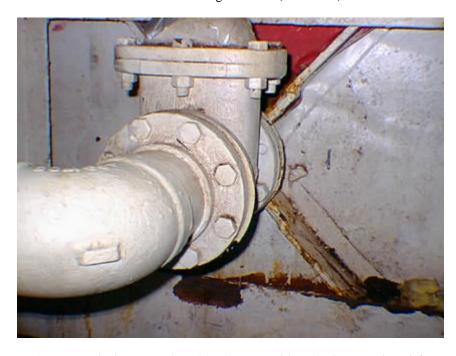
Area around eductor overboard, Fr 256, port side, L/L. Structure is satisfactory, but saturated lagging has caused considerable corrosion.

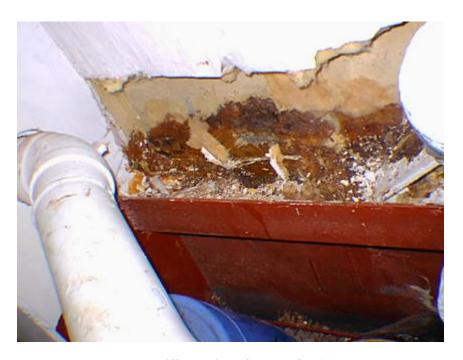
Different view of areas defined above

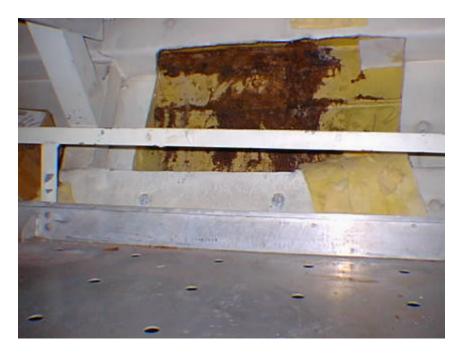
Heavy surface corrosion at a stiffener weep hole, FR 350

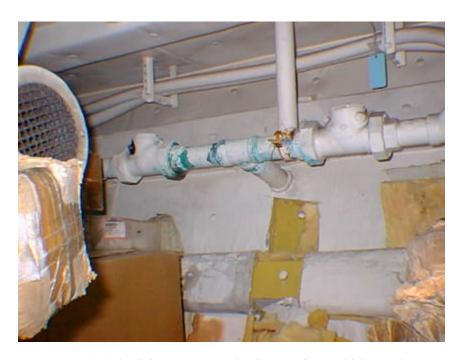
Deck drain piping. Note corrosion in way of several joints and hanger.

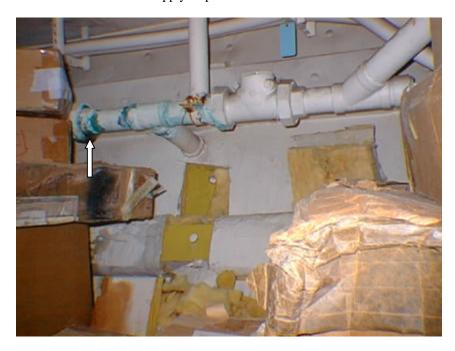
Arrow indicates leaking deck drain piping. Lagging removed for evaluation

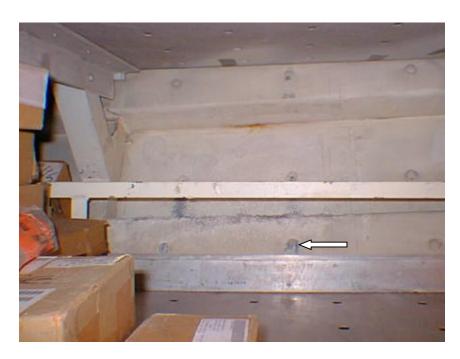
Lagging retaining buttons are completely corroded away, indicating long-term saturation.

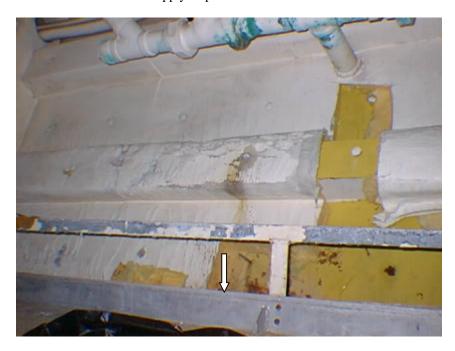
Lagging removed to ensure that overboard piping is not leaking. Corrosion starts on the next stringer down, in line with longitudinal pipe run.

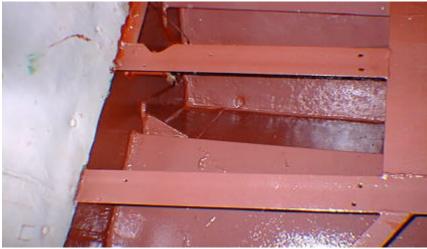
Deep pit in shell, Fr 106, port. Shell is ½" thick

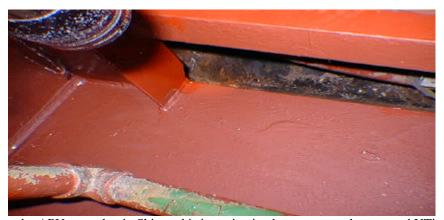
Corrosion under APU control unit. Shipyard is investigating how to get to the area and UTing.

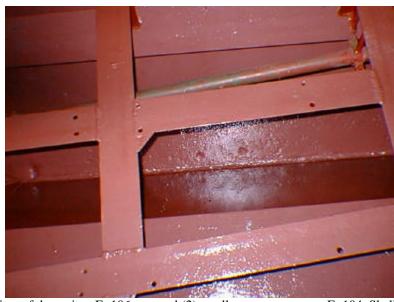
Additional view of deep pit at Fr 106 port and (2) smaller ones at approx. Fr 104. Shell is ½" thick.

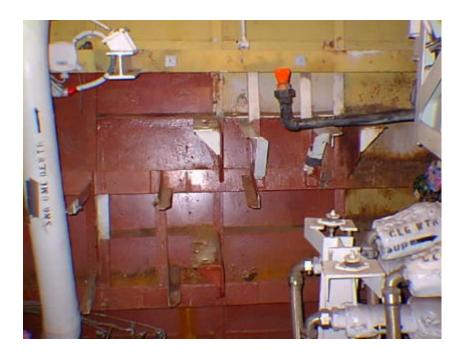
View of shell, stbd side Fr 49, 4<sup>th</sup> deck. Corrosion is typical of the class. Shipyard is replacing a stiffener and preserving the area

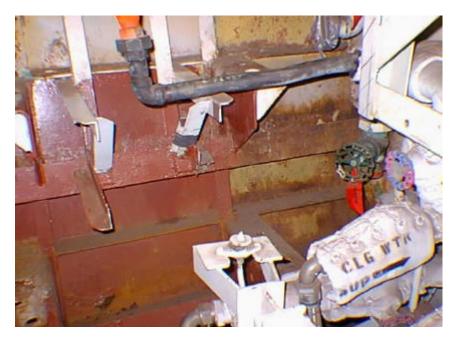
View of after bhd, showing corrosion in areas not accessible when equipment is installed.

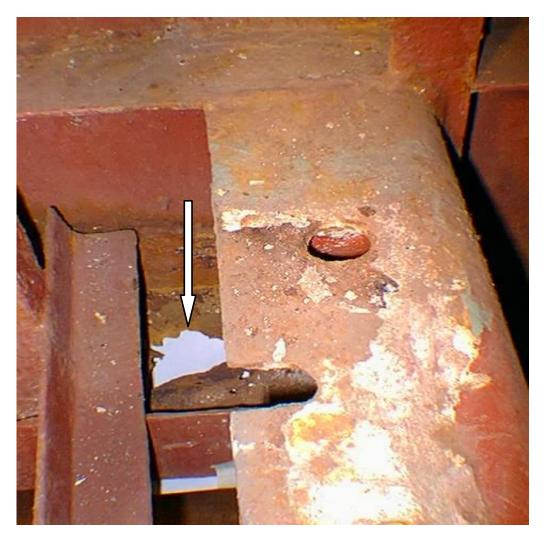
Arrow indicates a hole in the web of the web of the stiffener. A sheet of paper is under the hole to help show it . Shipyard is going to replace 12' of stiffener.

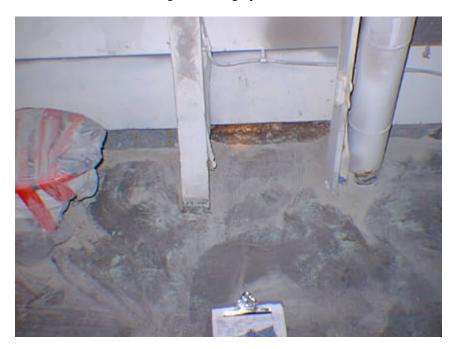
Corrosion noted at the connection between the  $3^{\rm rd}$  deck and shell. Shipyard will clean and preserve as part of space rehab
